DISTRICT OF CAMPBELL RIVER

**CAMPBELL RIVER NO. 1 FIREHALL
PRELIMINARY SEISMIC ASSESSMENT**

May 1995

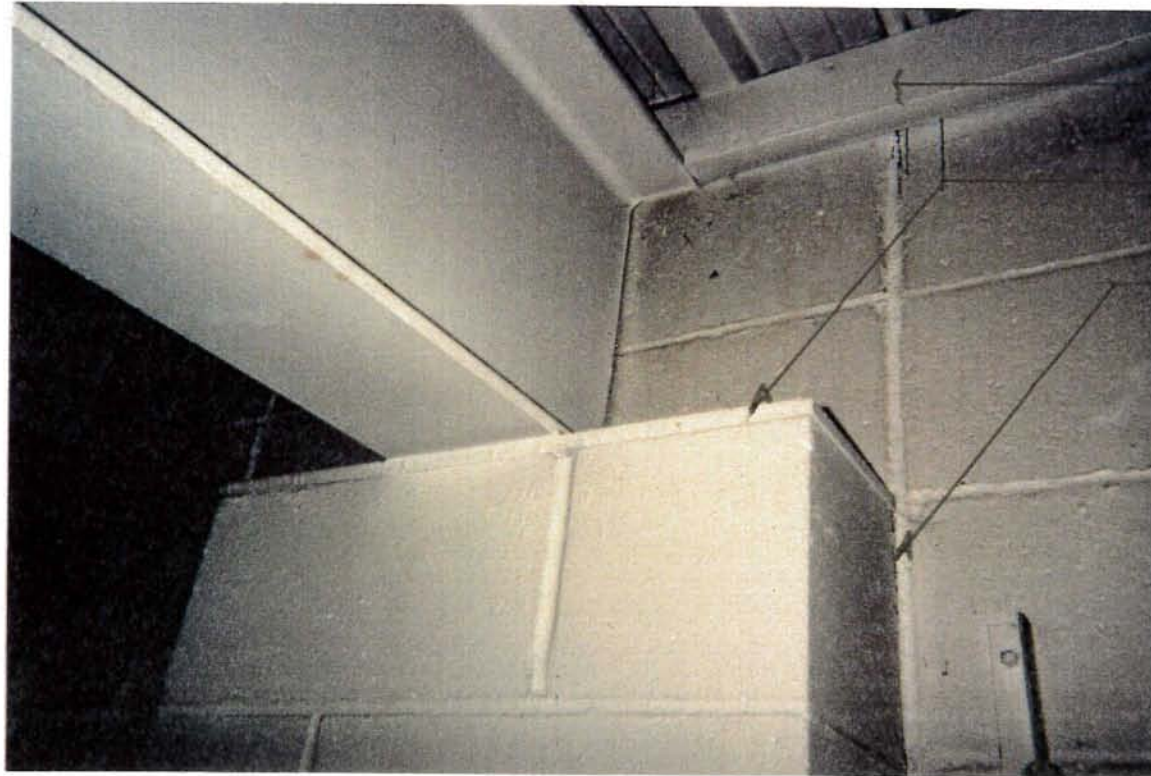
- 38 x 89 Wood Ledger
- Steel Bearing Plate
- Vertical Crack in Pilaster

Apparatus Floor Roof Beam/Pilaster Detail

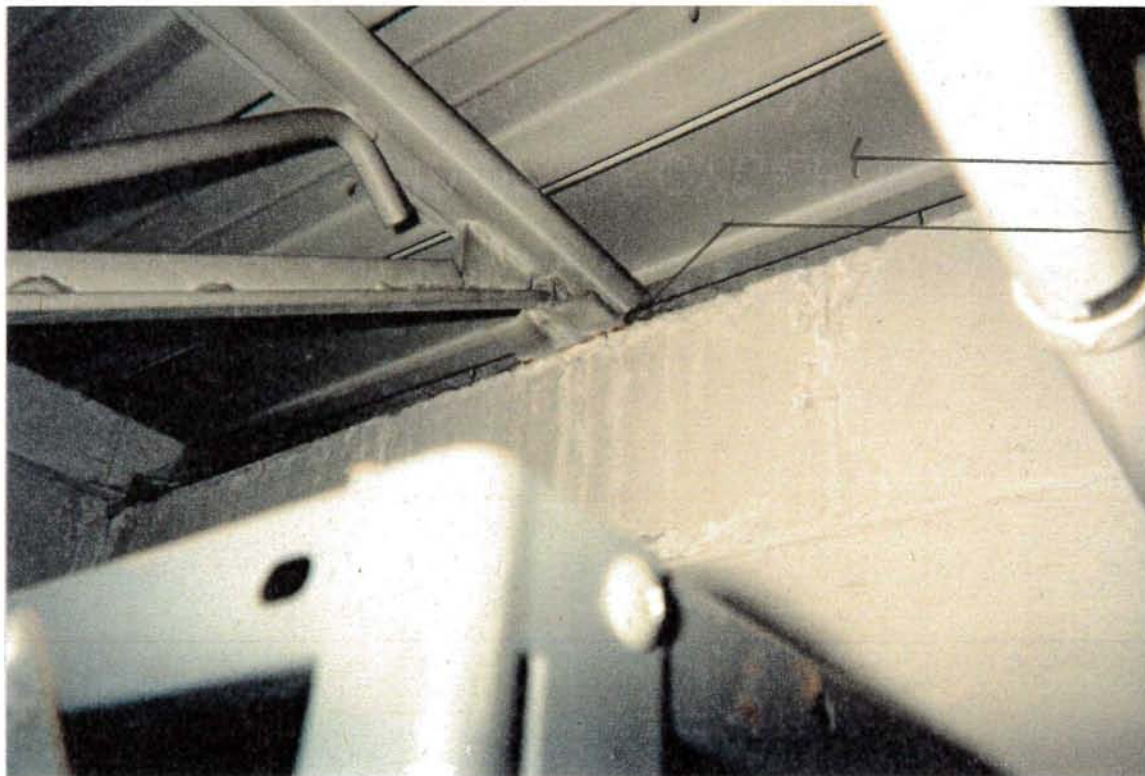
- Filler Flashing
- 64 x 150 Steel Bearing Plate

Roof Joist at South Wall of Maintenance Shop

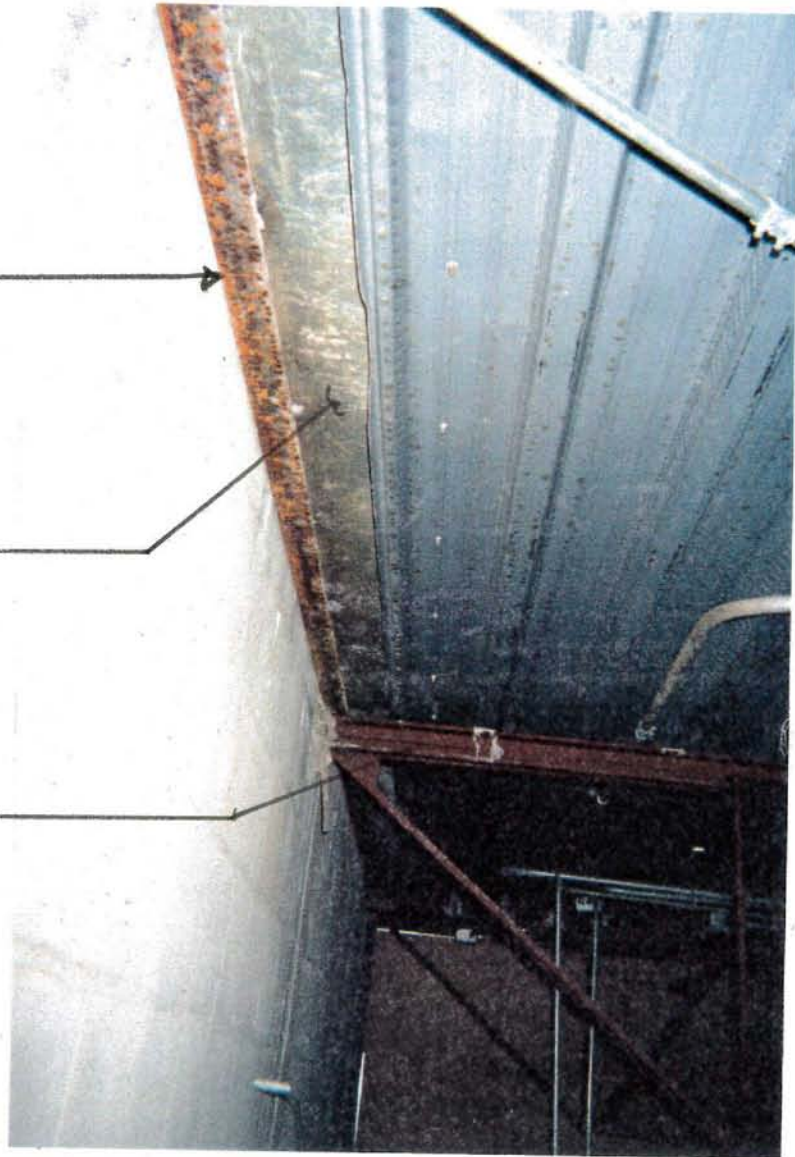
2nd Floor/Masonry Wall Connection Above Locker Room

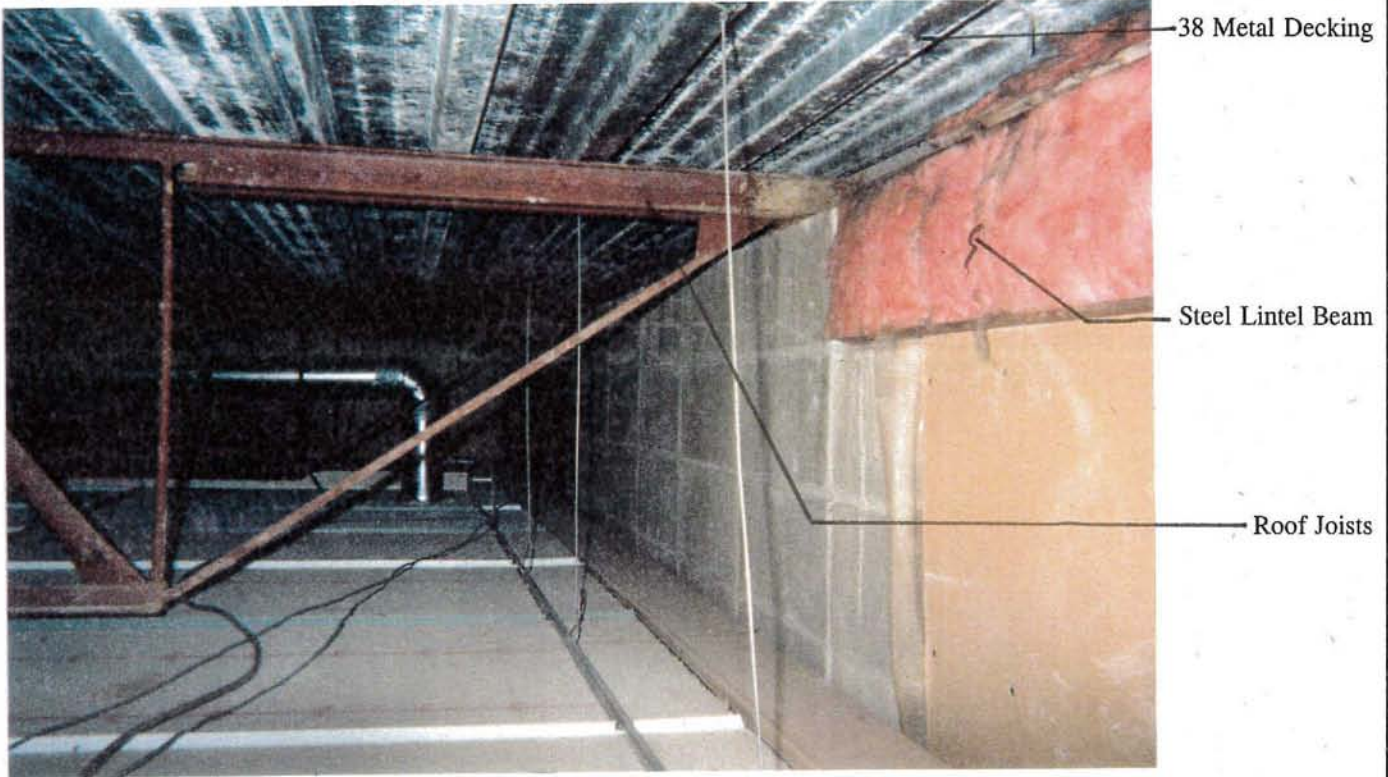
Roof Joist at North Office Wall
