April 27, 2017
Project No.: 5077-01

Geotechnical Investigation & Report

Proposed Residential Building – 1430 South Island Hwy – 19A,
Campbell River, B.C.

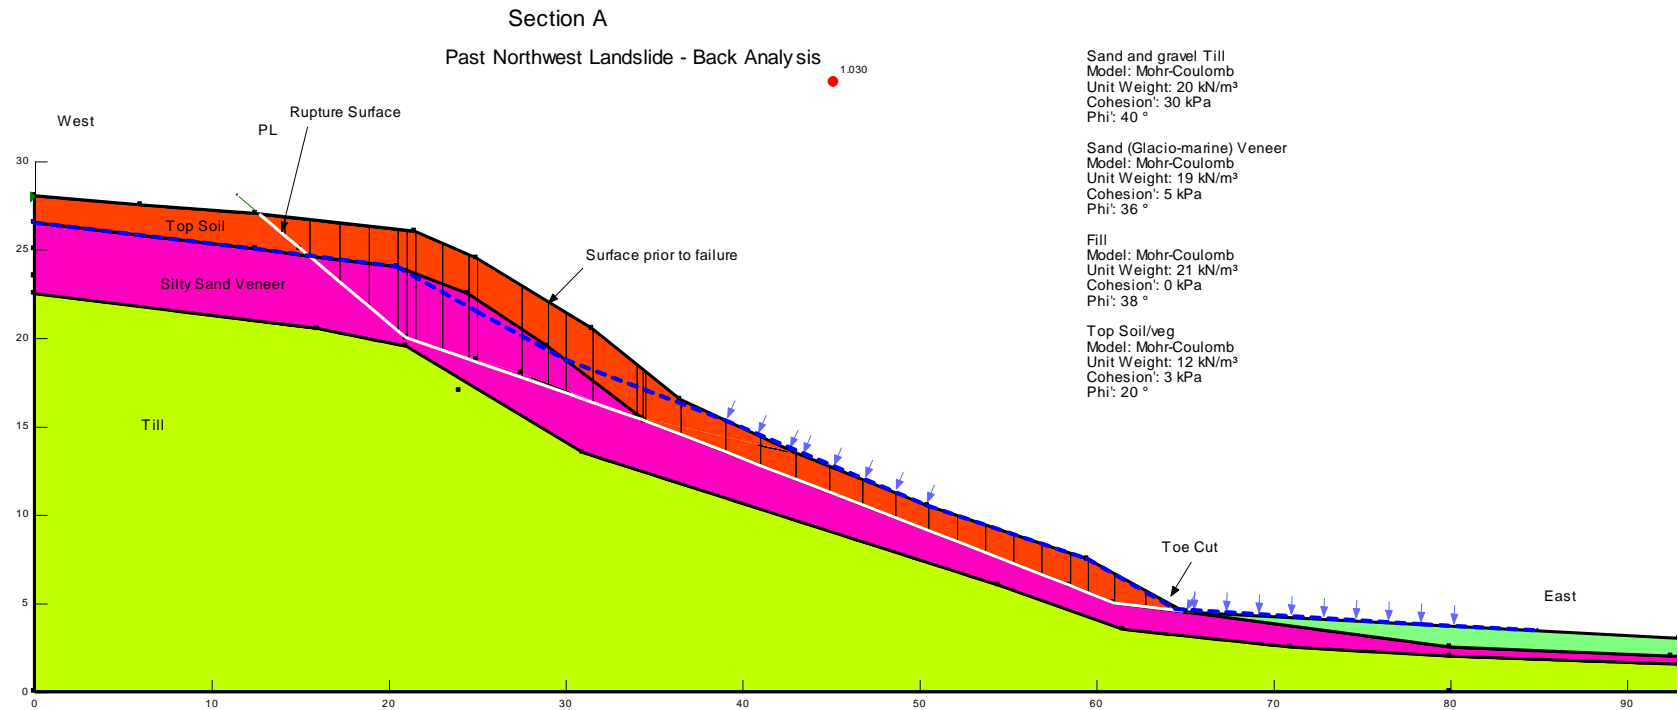
Figure 1: Back Analysis of Northwest Landslide

The northwest landslide was back analyzed assuming a translational slide where the rupture surface exits at the toe of the slope due to undermining activity that occurred at the toe of the slope (attributed as the main cause for the failure) and a high-water table. The stability model representing the back analysis is provided in Figure 1. The dimension of the landslide mass is approximately 2,700 m³, that spans 20 m to 30 m wide and 50 m in length with a runout distance estimated to be 20 m.

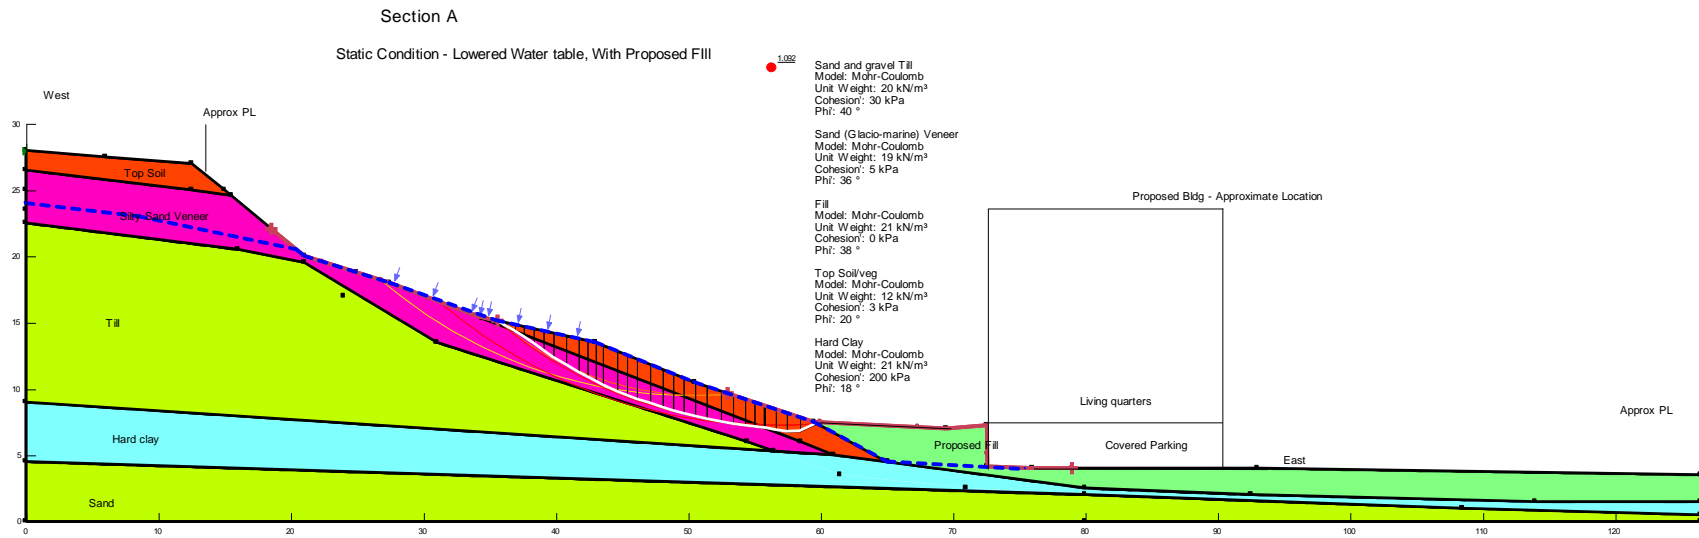
Figure 2: Section A Static Conditions / current Water Table

- 1) Slip surfaces less than FS<1.5 are shown.
- 2) Section corresponds to Northwest landslide

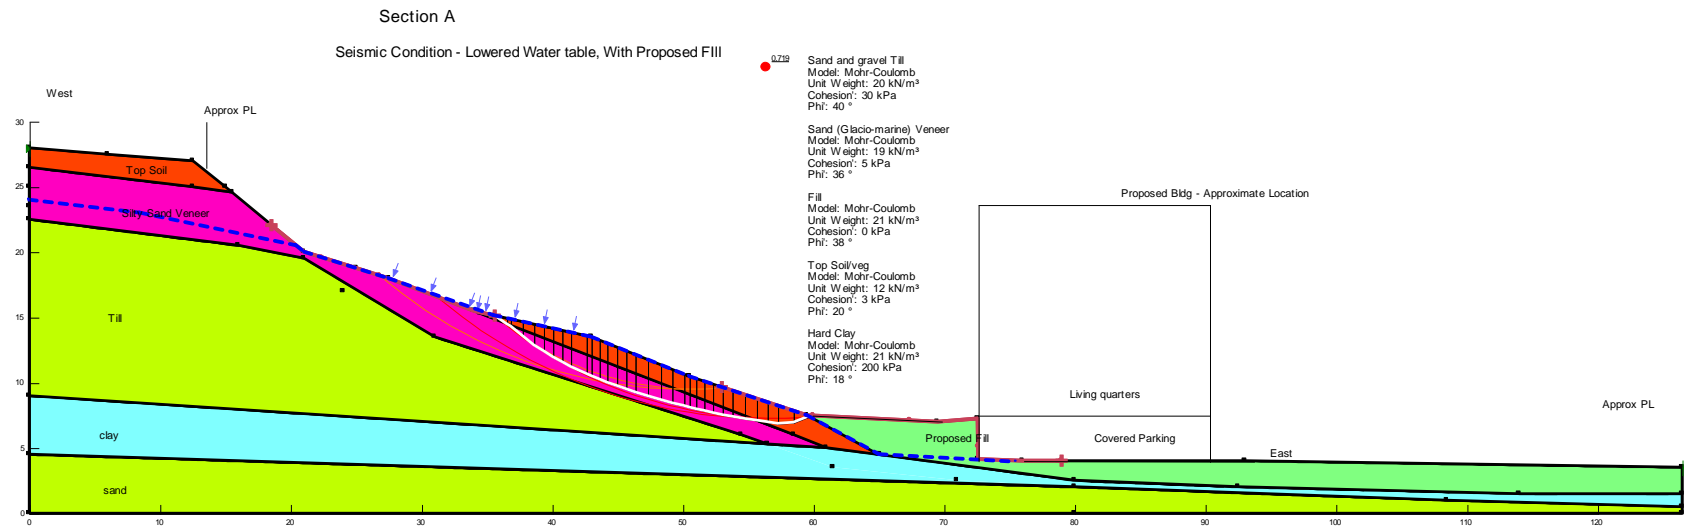
Figure 3: Section A Seismic Conditions / current Water Table

Based on the slope stability results, the slope is expected to fail during a design earthquake.

- 1) Slip surfaces less than FS<1.0 are shown.
- 2) Section corresponds to Northwest landslide

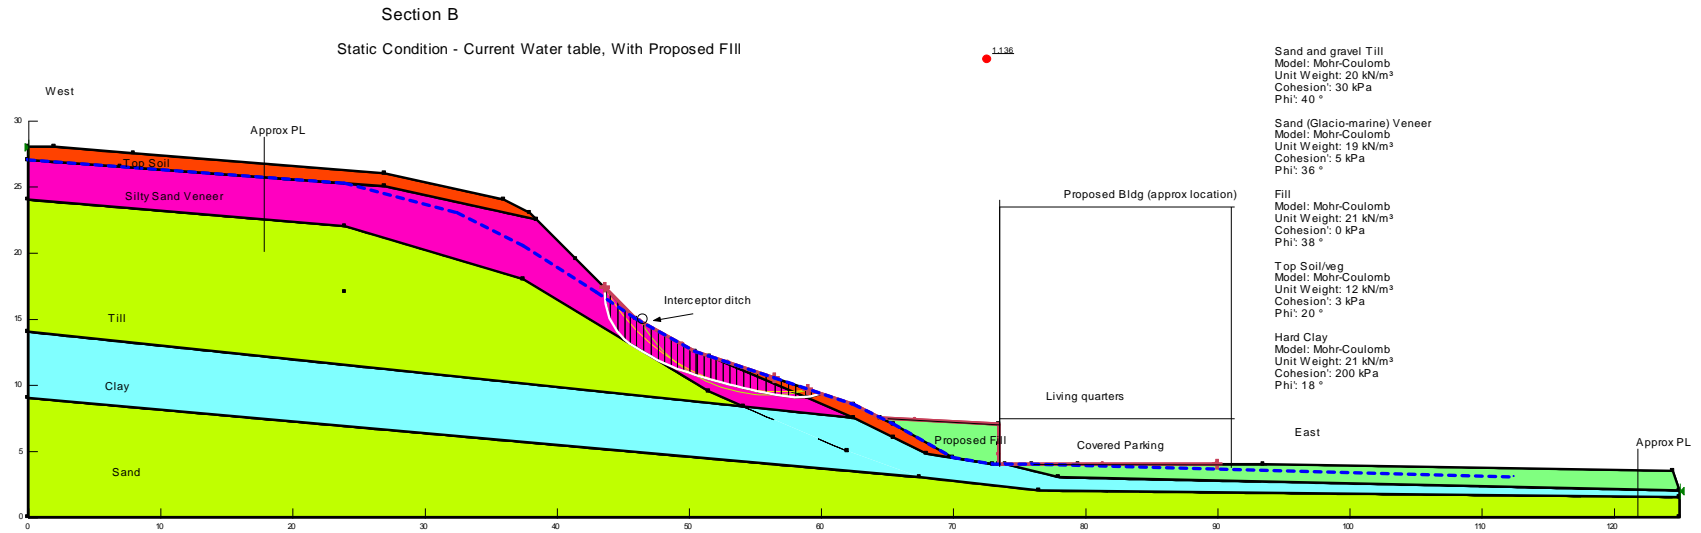
Figure 4: Section B Static Conditions (failures lower half of slope) / current water table

- 1) Slip surfaces less than FS<1.5 are shown.
- 2) Section corresponds to southwest landslide

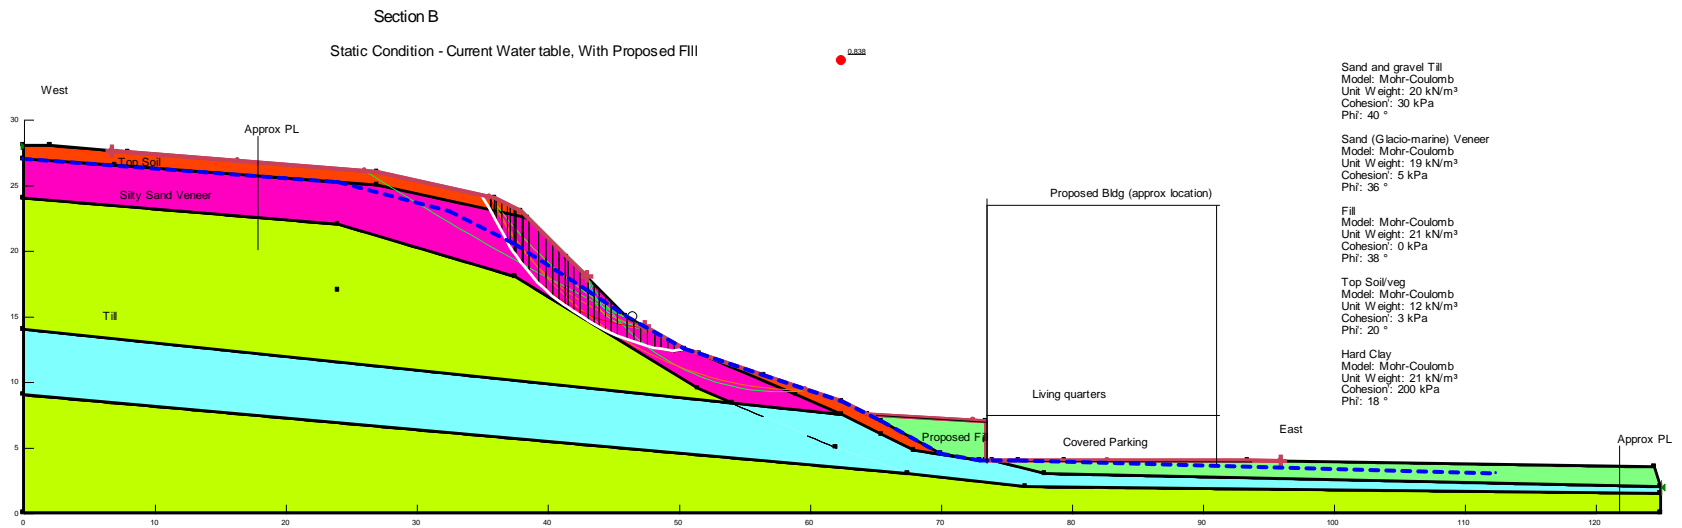
Figure 5: Section B Static Conditions (failures upper half of slope) / current water table

- 1) Slip surfaces less than FS<1.5 are shown.
- 2) Section corresponds to southwest landslide

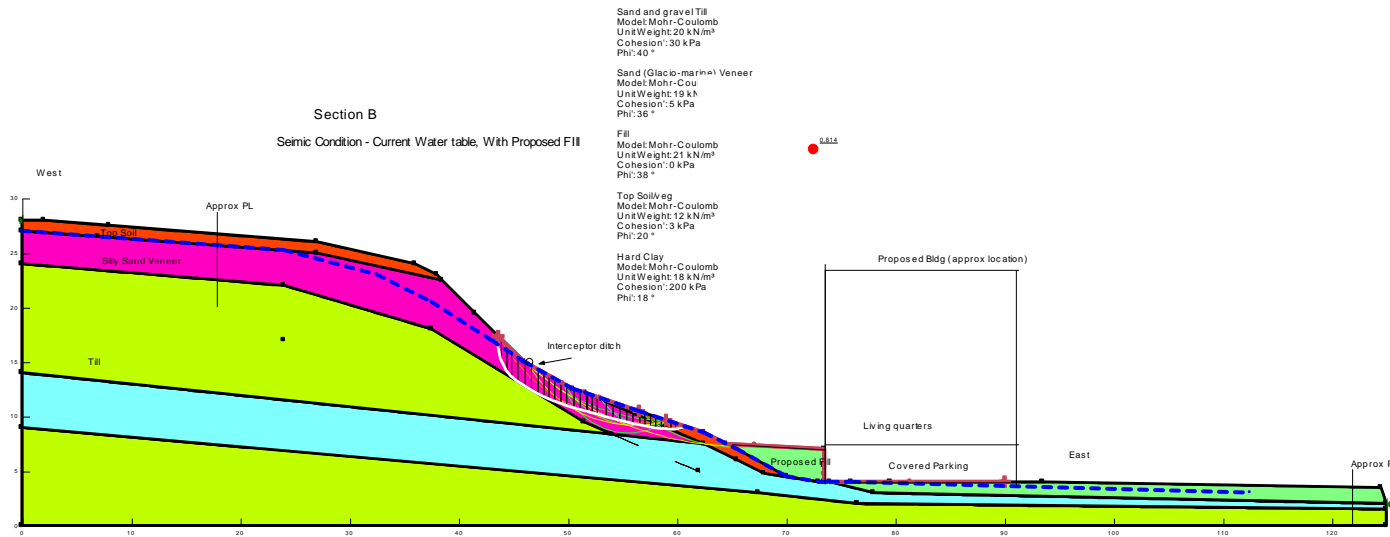
Figure 6: Section B Seismic Conditions (failures lower half of slope) / current water table

- 1) Slip surfaces less than FS < 1.0 are shown.
- 2) Section corresponds to southwest landslide

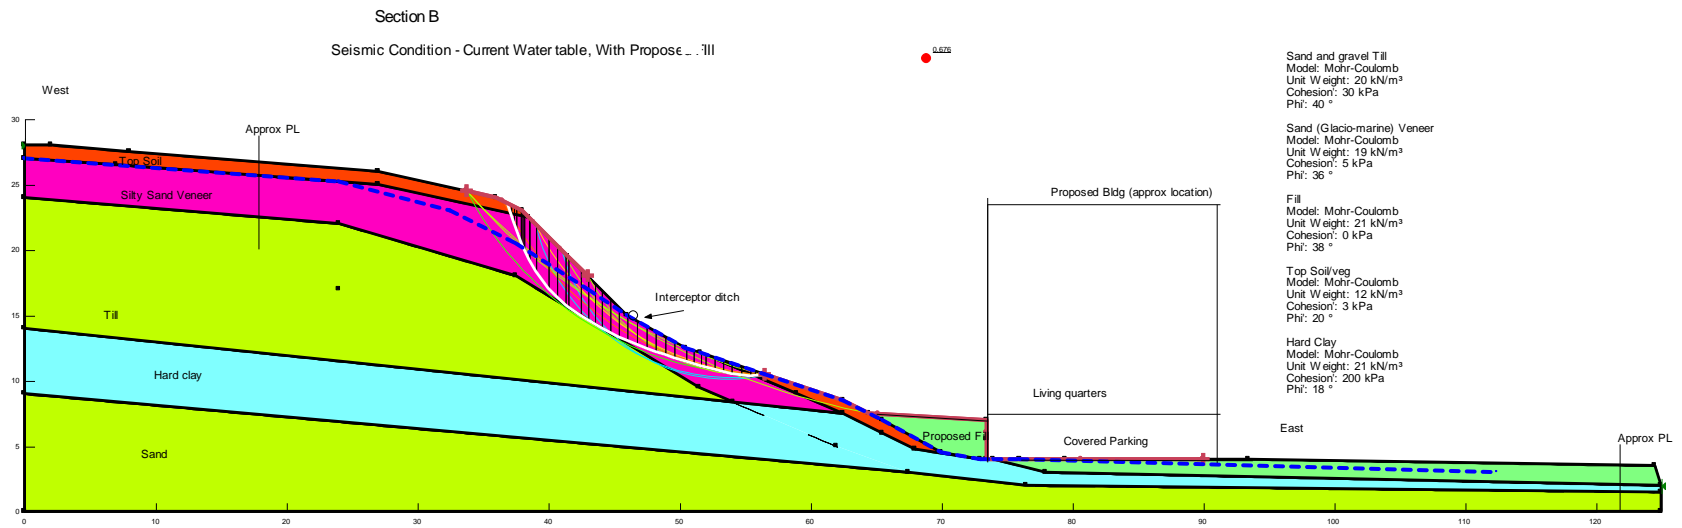
Figure 7: Section B Seismic Conditions (failures upper half of slope) / current water table

- 1) Slip surfaces less than FS<1.0 are shown.
- 2) Section corresponds to southwest landslide.

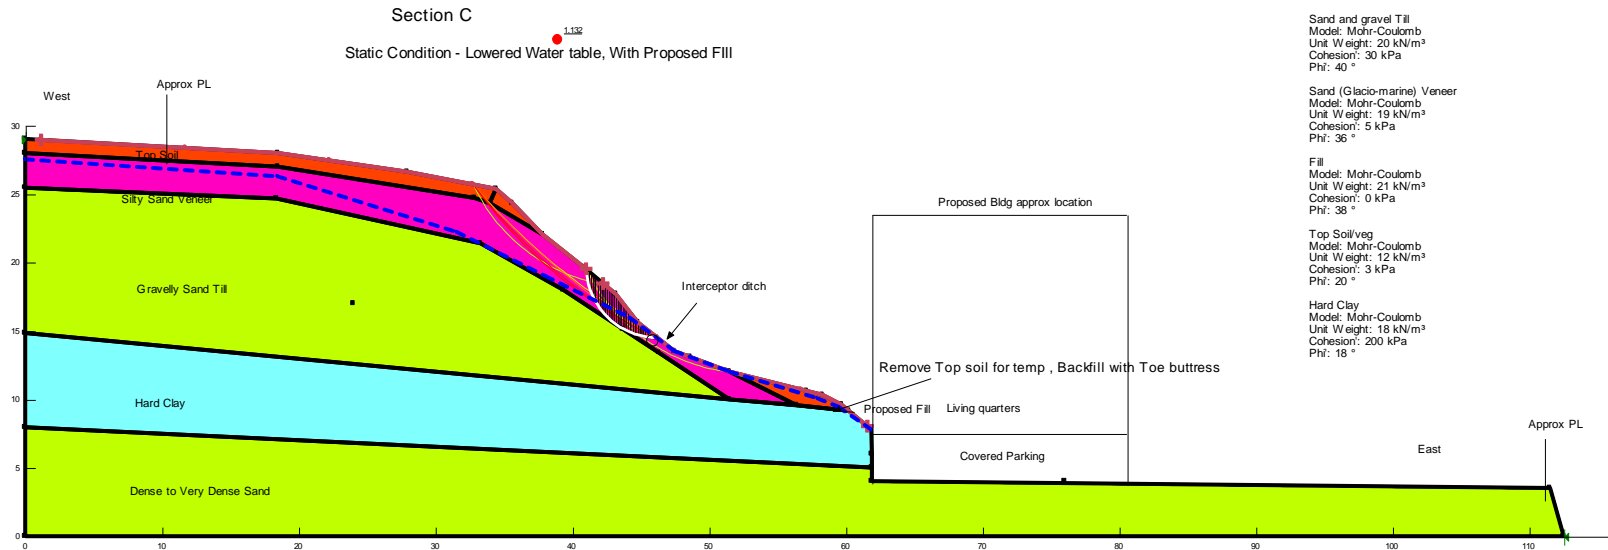
Figure 8: Section C Static Condition (failures upper half of slope) / current water table

- 1) Slip surfaces less than FS<1.5 are shown.

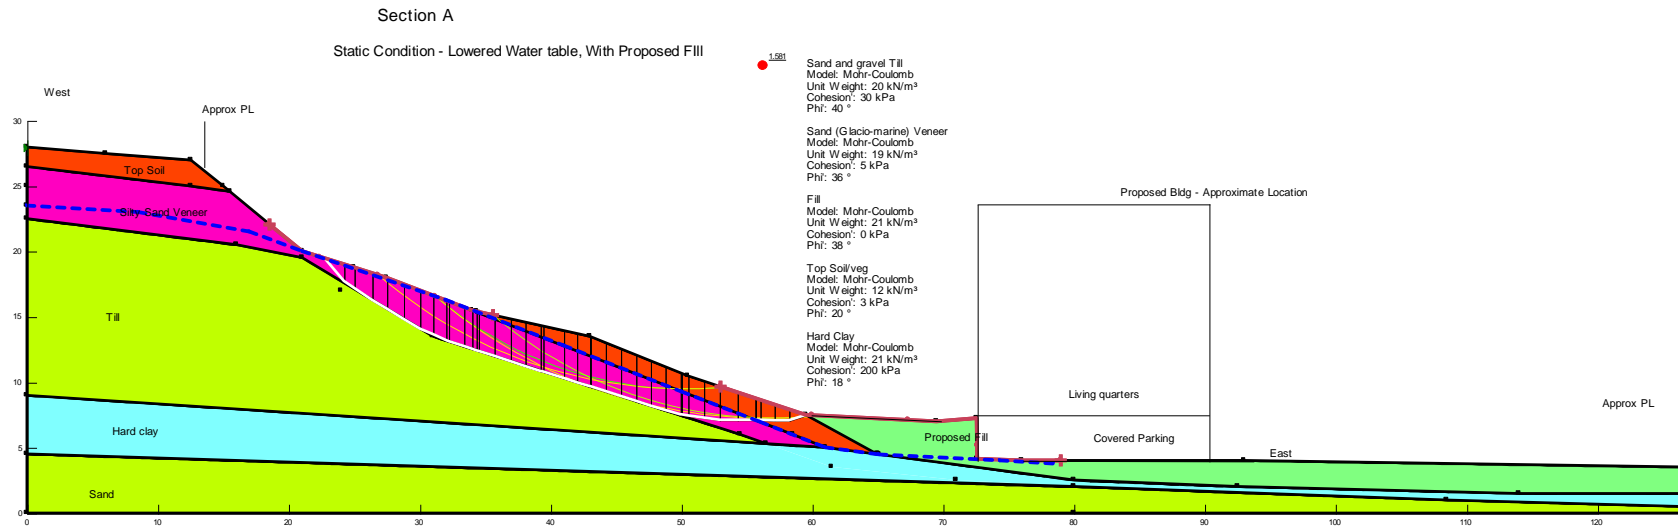
Figure 10: Section A Static Case, lowered water table with drain pipes and interceptor ditches

- 1) Lowest Factor of Safety shown in figure.
- 2) Section corresponds to northwest landslide.

- Horizontal drainage pipes drilled into toe and mid slope (within the sandy veneer) to reduce the water level and reduce seepage;
- Interceptor ditches located mid slope on an existing natural bench to collect surface water runoff that can be directed into drainage pipes and discharged at the toe of the slope;
- Revegetation of the slope that is bare of vegetation;
- Designated landslide run-out zone in the rear portion of the building; and
- No habitable areas in the rear portion of the building (southwest) facing upslope on the second floor and no openings in the foundation wall below 9.50 m (See Zone 2 - Drawing 3).

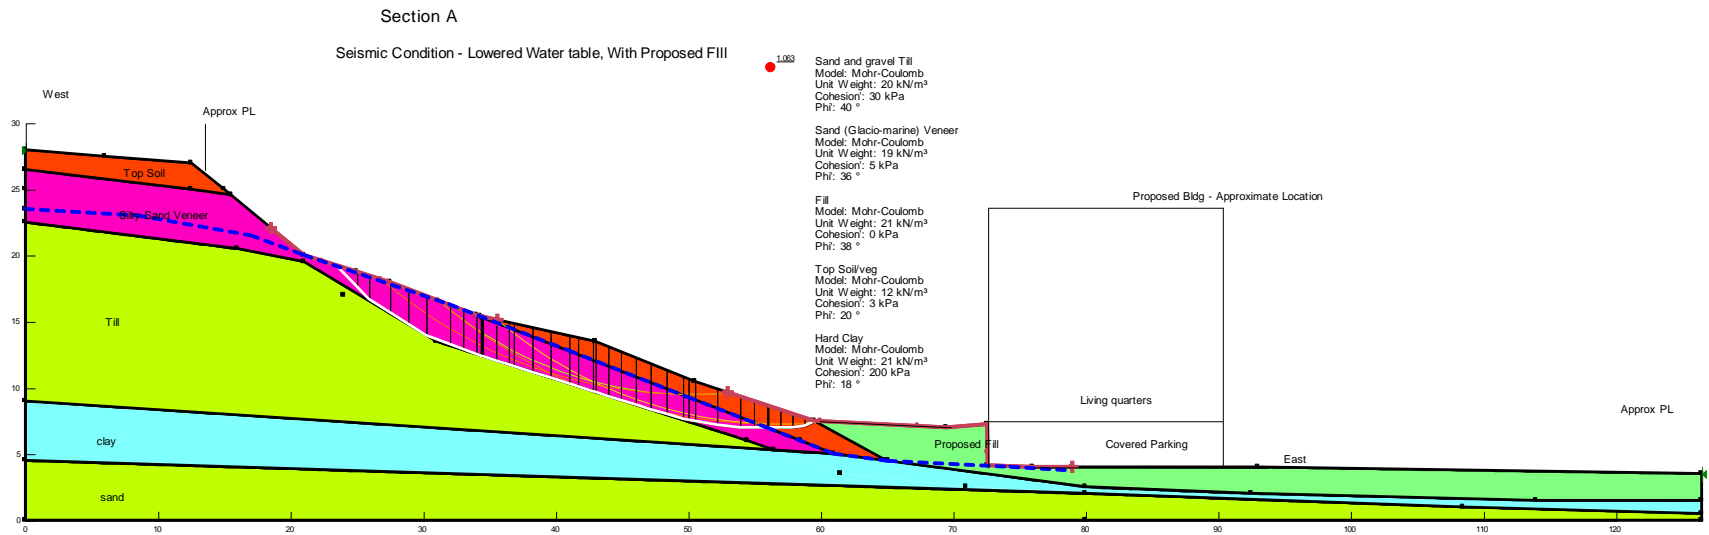
Figure 11: Section A Seismic Case, lowered water table with drain pipes and interceptor ditches

- 1) Lowest Factor of Safety shown in figure.
- 2) Section corresponds to northwest landslide.

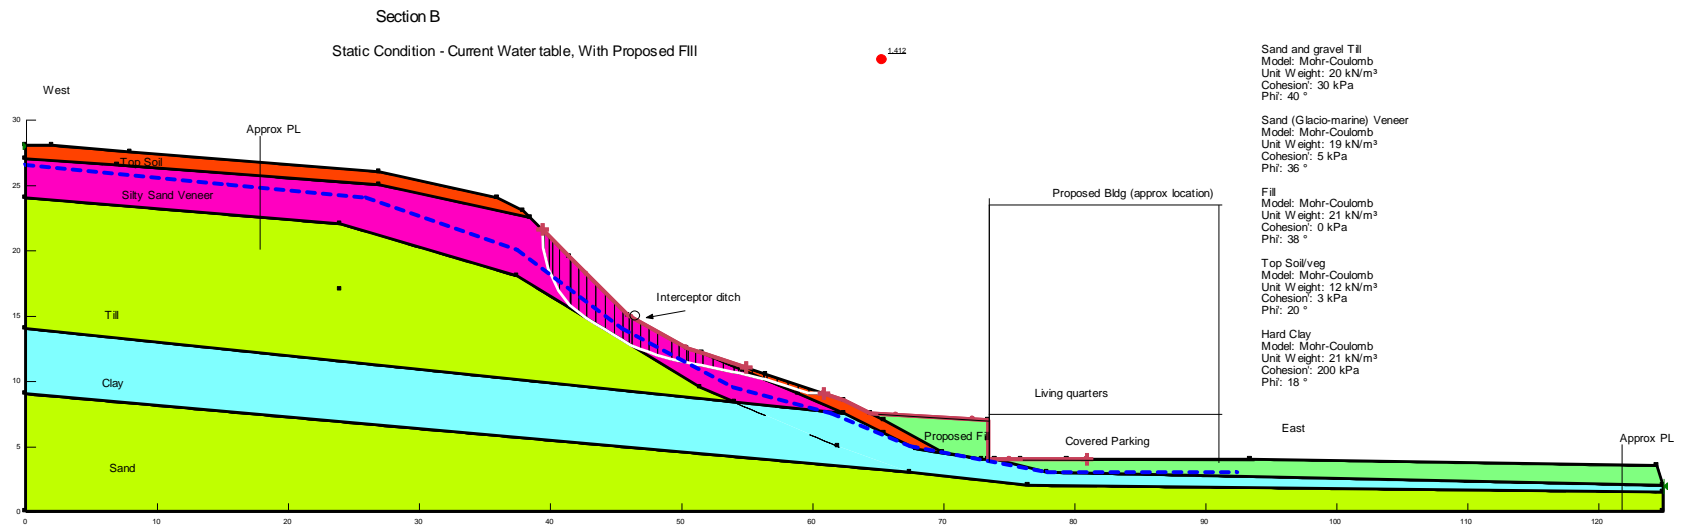
Figure 12: Section B Static Case, lowered water table with drain pipes and interceptor ditches

- 1) Factor of Safety less than 1.5 shown or lowest FS.
- 2) Section corresponds to southwest landslide.

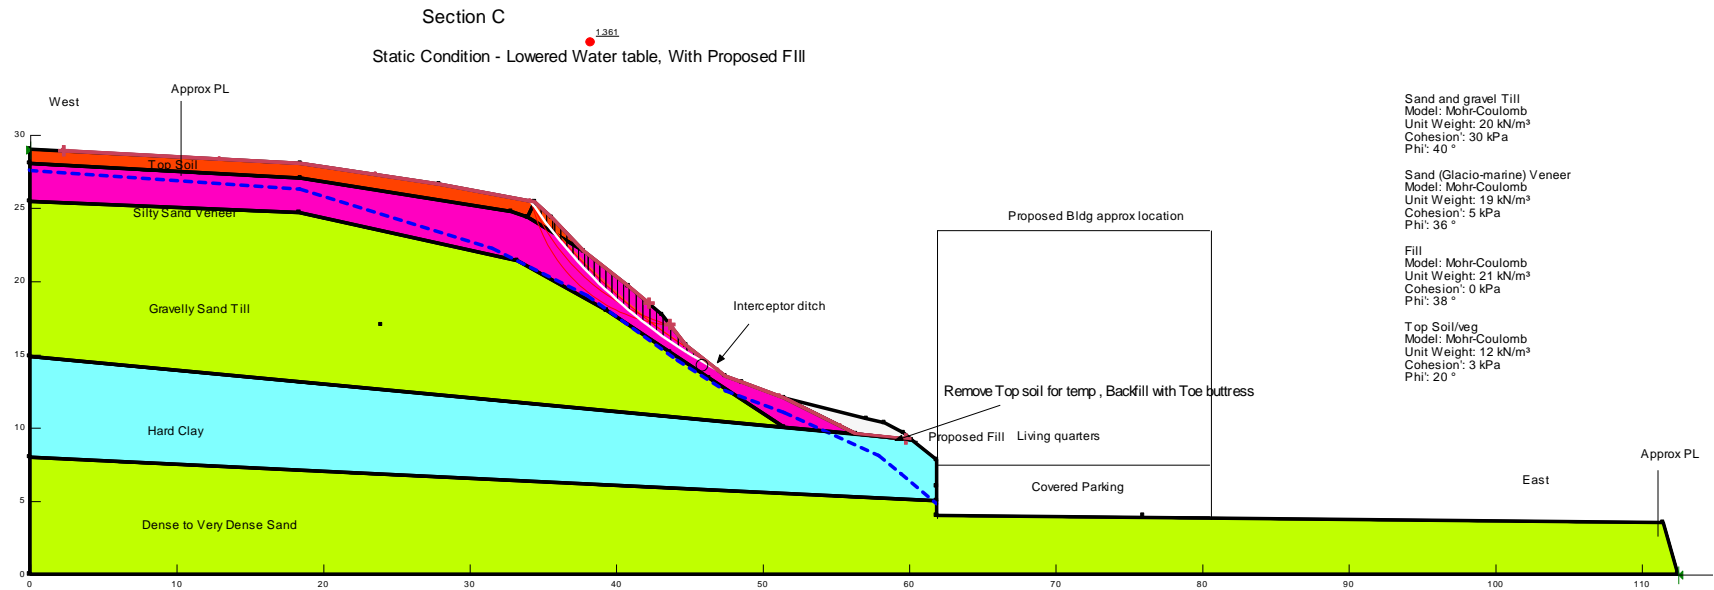
Figure 13: Section C Static Case, lowered water table with drain pipes and interceptor ditches

- 1) Factor of Safety less than 1.5 shown or lowest FS.

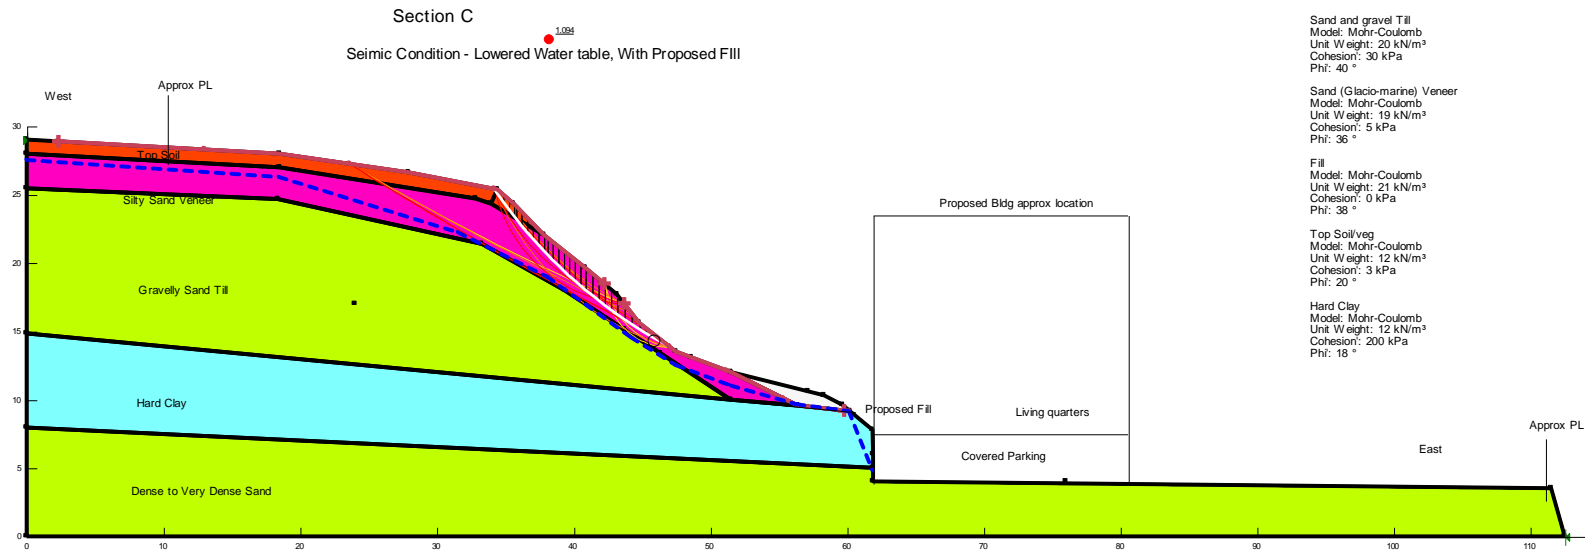
Figure 14: Section C Seismic Case, lowered water table with drain pipes and interceptor ditches

- 1) Factor of Safety less than 1.5 shown or lowest FS.

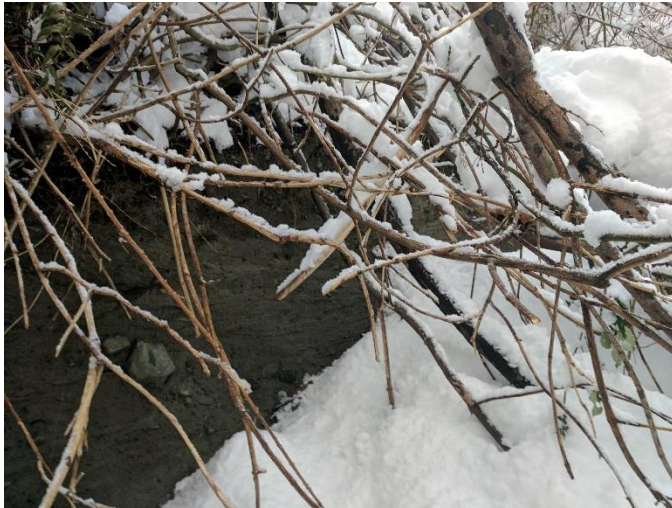
Photo 1: Exposed Till layer outcrop (2/3 up slope near section B)

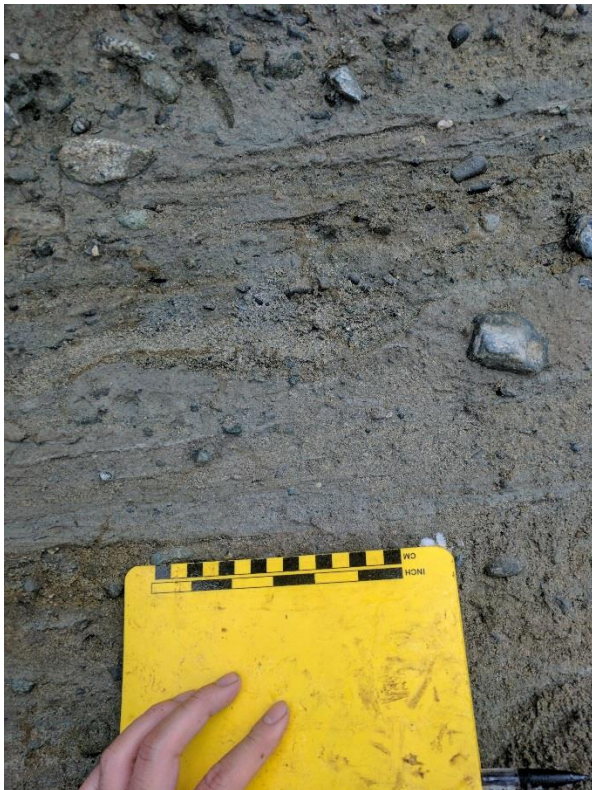
Photo 2: Close up of exposed Till layer outcrop (2/3 up slope near section B)

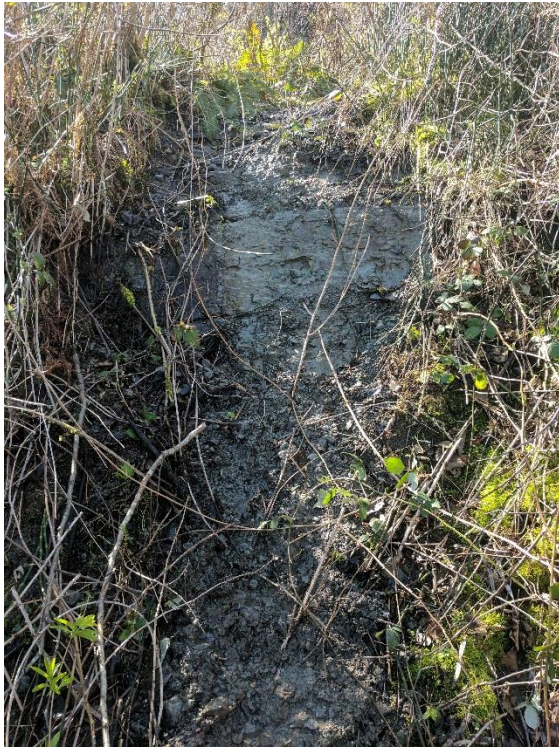
Very firm to hard clay soil outcrop was observed at the existing toe of the slope near the south property line. The hard clay layer was observed to be approximately 4.5 m thick, and cut vertically by mechanical means during past site grading work (see Photo 3 and 4 in Appendix A). The hard clay is considered to be associated with the marine till deposit. This soil layer is considered impermeable and any groundwater from the slope is draining overtop through the sand veneer and topsoil.

Photo 3: Exposed Hard Clay layer at the toe of slope at Section C

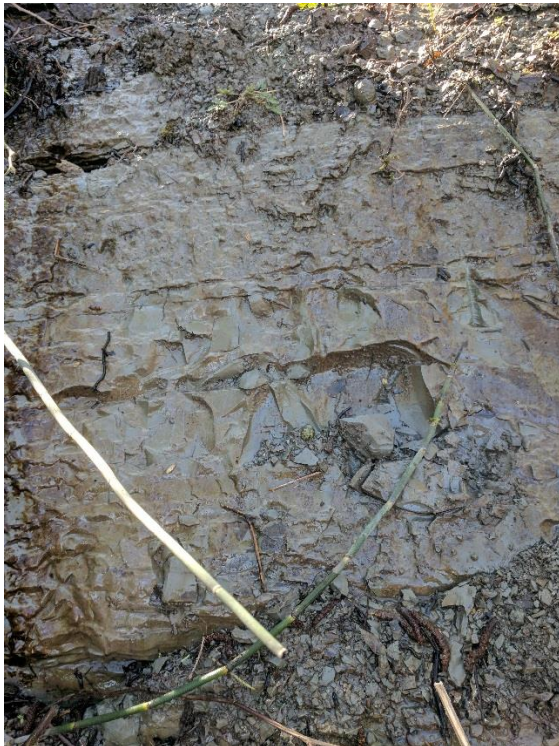
Photo 4: Exposed Hard Clay layer at the toe of slope at Section C
