REQUEST FOR PROPOSAL 19-37 SPORTSPLEX RENOVATIONS CONSULTING SERVICES

The City of Campbell River is seeking the services of a qualified Architectural Consulting firm to assist with major renovations to the Campbell River Sportsplex.

To The Owners, City Of Campbell River Draft Submitted April 4, 2019 by c/o Mr. Jason Decksheimer **City Of Campbell River** 385 S Dogwood St **Campbell River BC V9W 8C8**

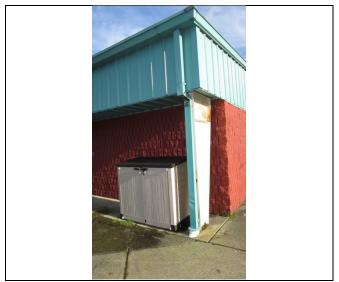
Photo 1 B1021 Steel I-beams require Painting

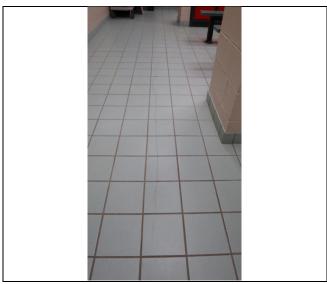
Photo 2 A1031 Crack in Slab-on-Grade near GL's 9.1 & Q

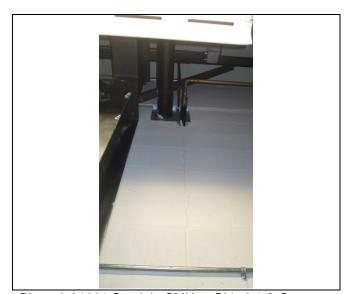
Photo 3 A1031 Crack in CMU at GL's 9.1 & O

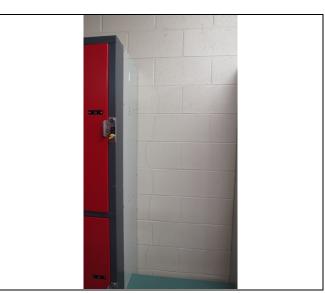
Photo 4 A1031 Crack in CMU at GL's 9.1 & M

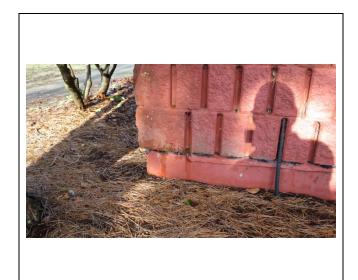
Photo 6 B2011 Water behind masonry Block

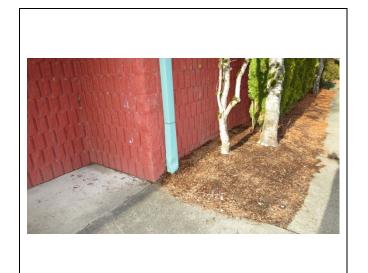
Photo 7 B2011 Landscape Grade above Finished Floor

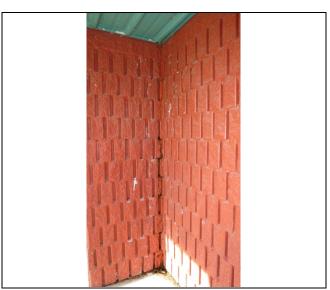
Photo 8 B2011 Roof Leak Water behind masonry Block

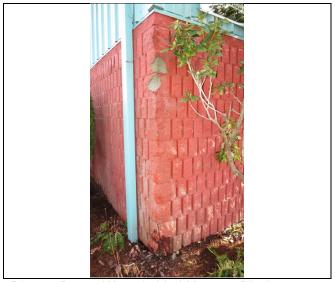
Photo 9 B2011 Water behind Masonry Block-Deteriorating Corner

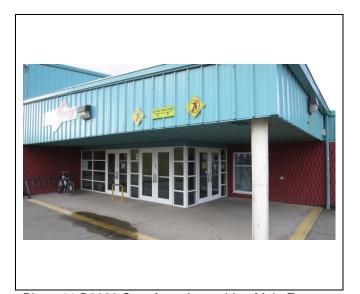
Photo 11 B2023 Storefront Assembly - Main Entry

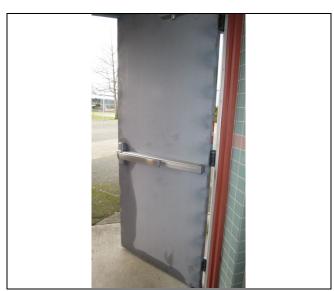
Photo 12 B2032 Exterior Doors require Paint

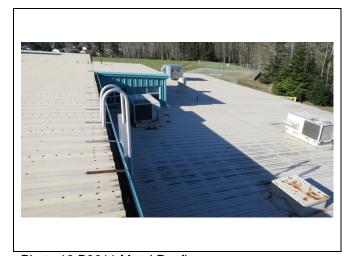
Photo 13 B3011 Metal Roofing

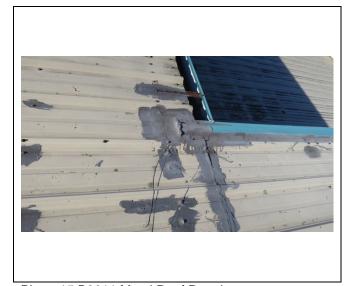
Photo 15 B3011 Metal Roof Repair

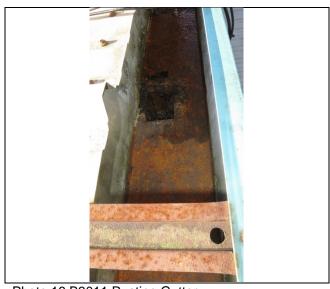
Photo 16 B3011 Rusting Gutter

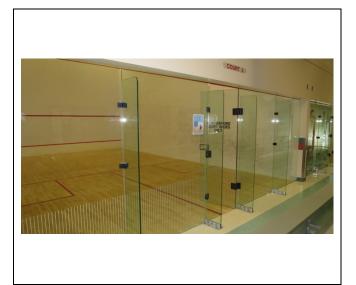
Photo 19 C1013 Non-Movable Court Glass Wall

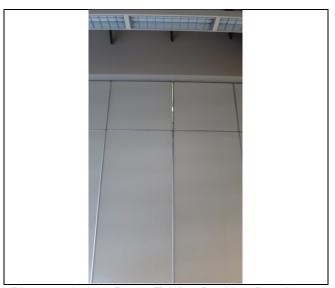
Photo 22 Activity Room Folding Partition-Requires maintenance

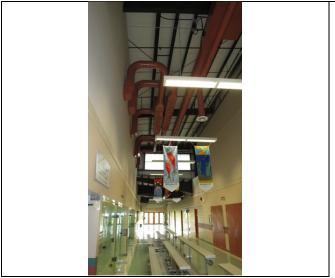
Photo 29 C3033 Painted Ductwork & Ceiling Purlins

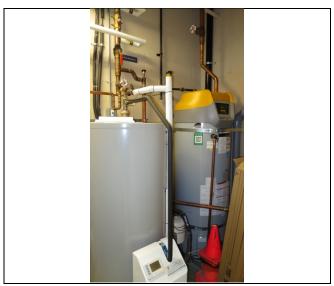
Photo 34 D2022 - Hot Water Service

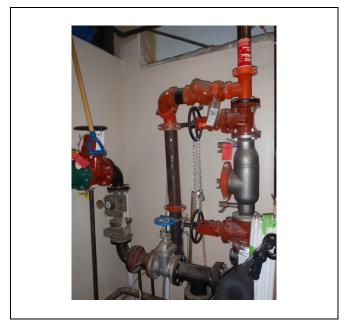
Photo 37 D4011 - Sprinkler Tree

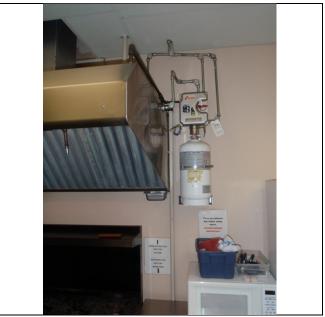
Photo 38 D4095 - Hood Fire Protection

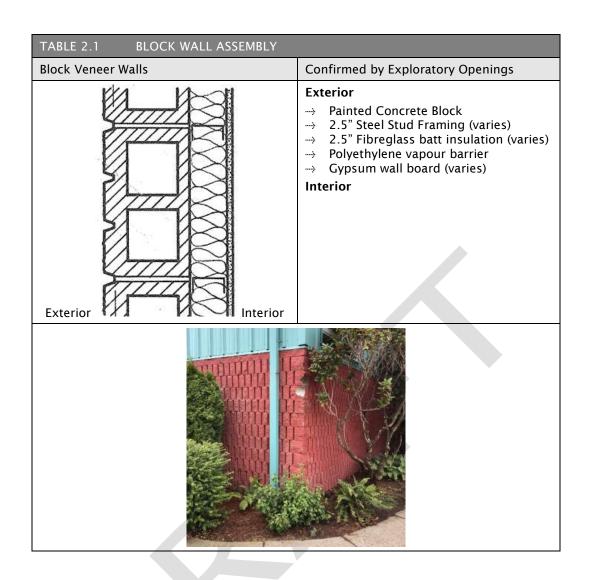
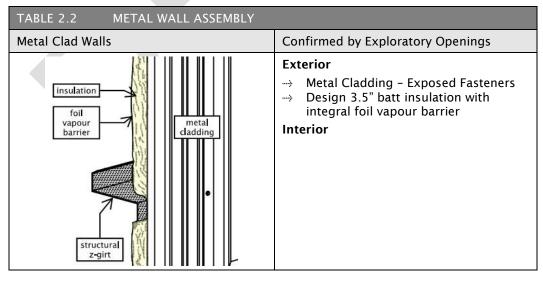
- → The lower level of wall consists of painted block against an insulated steel stud back up wall. Refer to Table 2.1 below.
- → Metal cladding installed directly onto the metal wall structure. Faced batt insulation is compressed against the back of the metal cladding. Refer to Table 2.2 below.

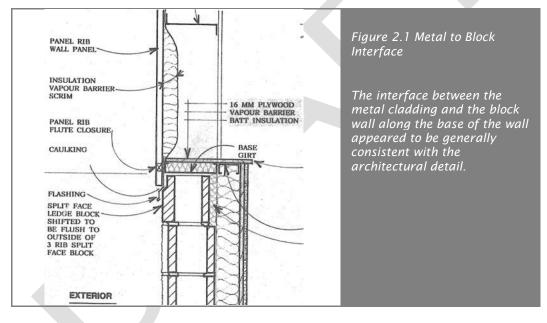
→ The interface between the metal cladding and the block wall generally reflects the architectural details. Refer to Figure 2.1 below.

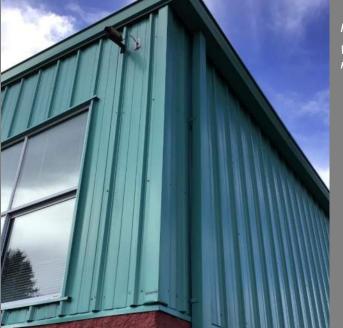
Figure 2.2 Wall Protection Wall cladding is exposed to rain fall.

→ Overhangs can provide a varying degree of protection for the exterior walls. The majority of the walls have no overhang protection (Figure 2.2) and are considered to have a high exposure to weather.

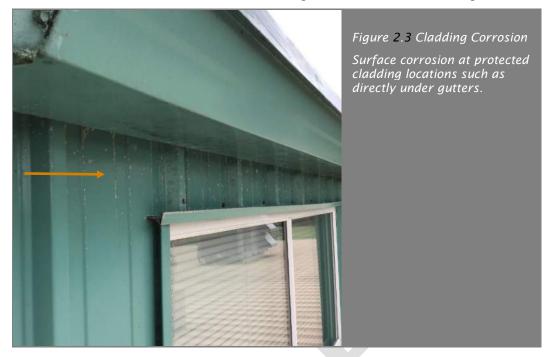
→ Corrosion on the surface of the metal cladding under covered locations (Figure 2.3).

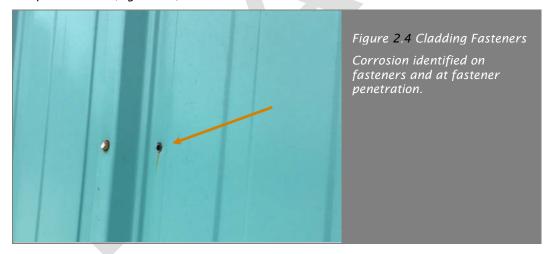
→ Surface corrosion on exposed cladding fasteners and on metal panel at fastener penetrations (Figure 2.4).

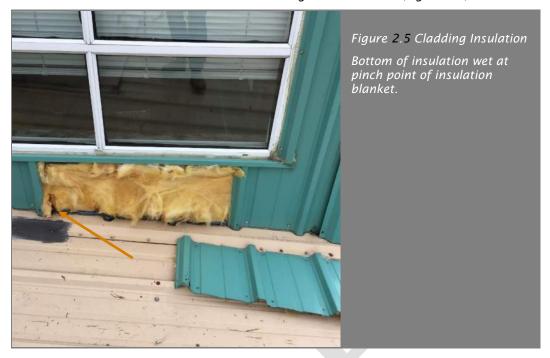
→ Wet insulation at base of wall details including below windows (Figure 2.5).

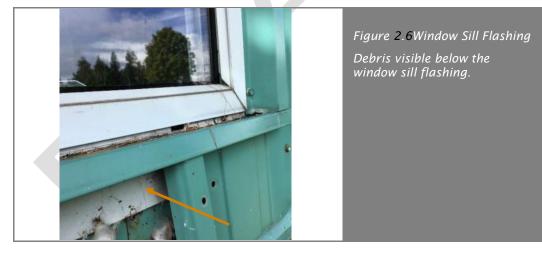
→ Window head flashing and sill flashings are originally installed without a seal to the window which can result in unintended wetting of the insulation behind the metal cladding (Figure 2.6). Many window perimeters have had remedial sealant installed.

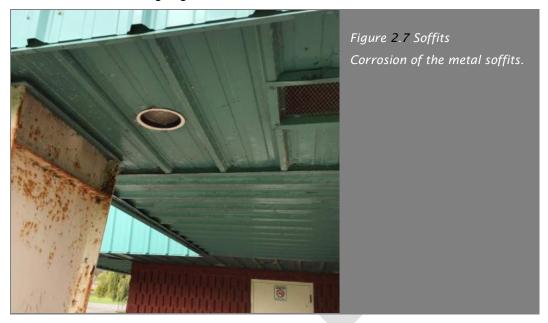
→ The metal soffits are generally an extension of the wall cladding. The profile and colour are the same as the metal cladding. The majority of the metal soffits were found to be corroding (Figure 2.7).

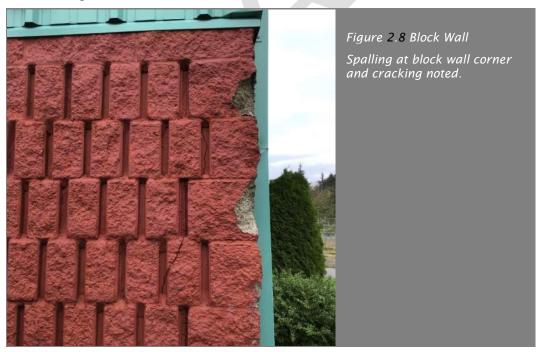
→ Cracking in the block wall was observed at several locations as well as spalling of the block (Figure 2.8).

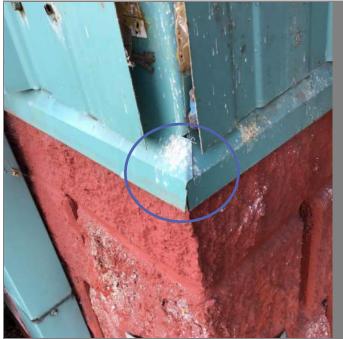
→ Joints in the sill flashing at the base of the metal cladding above the brick was simply overlapped at the few locations reviewed (Figure 2.9). The sill flashing is intended to protect the top of the block wall. It is noted that much of the block spalling and efflorescence is occurring at corners.

Figure **2.9** Cladding Sill Flashing Open joint in the head flashing of the block wall.

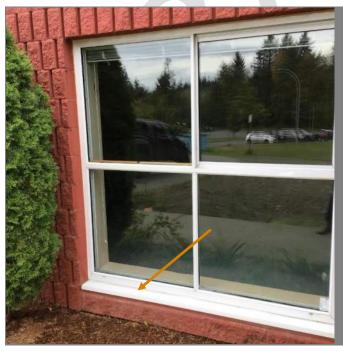
Figure 2.10 Window Sill Flashing

→ Window sill flashings and perimeter sealant are in place to protect the block (Figure 2.10). The sill flashing is intended to protect the top of the block wall.

Covers the bottom course of block.

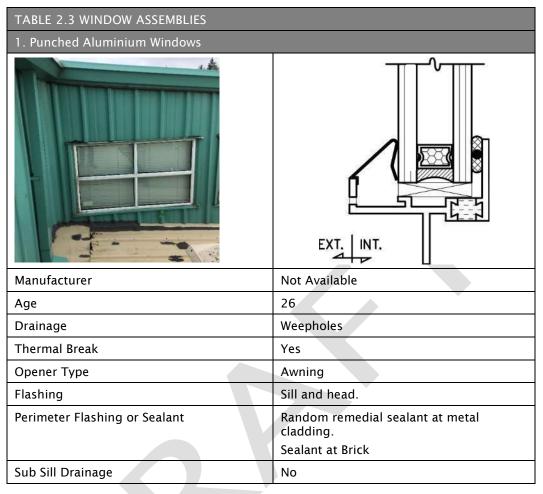
The windows rely on the exterior metal glazing stop to shed water away from the horizontal mullions of the window frame. The lack of a seal between the metal glazing stop and the glass due to discontinuities in the gaskets can allow a significant amount of water to enter into the glazing cavity beneath the glass. To prevent water that enters the glazing cavity from leaking into the building, there is:

- → A gasket of glazing tape seal between the innermost face of the glass and the window frame.
- → A thin cap seal application of silicone seal over the irregular surface interface at the screw fastened mitre corners of the aluminium window frame.

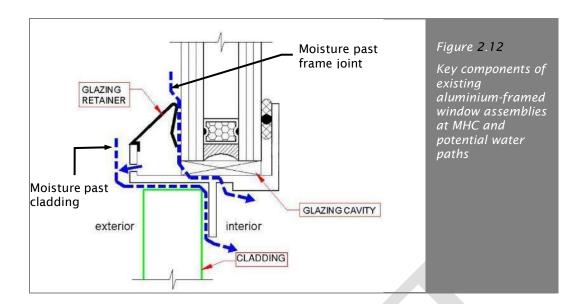
The sealant at the mitred corner joints is susceptible to failure and screw splines and interfaces are vulnerable to leakage. At the exploratory openings made below windows, we did observe evidence of water leakage directly below the windows into the wall construction below, however we did not observe damage to the concealed metal materials

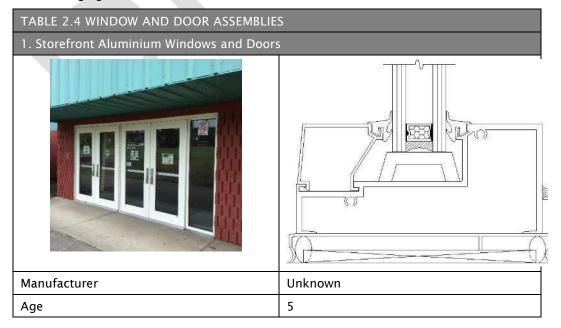
This type of storefront window assembly is typically intended for areas low exposure to wind driven rand and typically would be installed at locations with overhangs. These windows have insulated glazing units with an aluminum spacer bar which is appropriate for these large glass sizes.

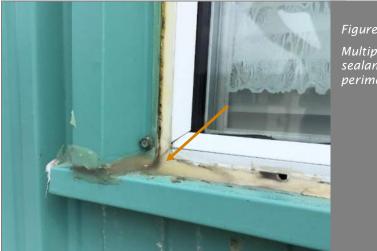
→ Remedial exterior perimeter sealant at the upper level windows on most elevations (Figure 2.13). This sealant has reached the end of its effective service life at most locations reviewed.

Figure 2.13 Window Sealant Multiple applications of sealant installed at window perimeters.

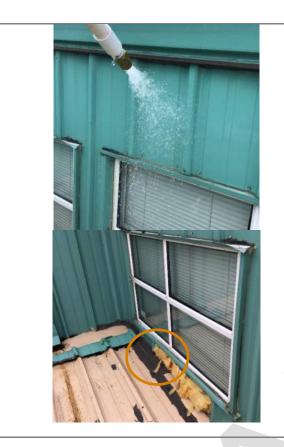
→ We performed localized spray testing to identify the source of ongoing leakage below the hall way clerestory windows on the east elevation. Water was directed at the centre of the windows and at the perimeter interface with the cladding (Figure 2.14). No water ingress was observed dripping on the interior during the test. When the metal cladding was removed below the window we found that the insulation was wet. The water testing identified discontinuities in the perimeter interface of the window.

Figure 2.14 Water Test
Water testing at the hall
window on the east elevation
and the resultant moisture
identified in the insulation
below.

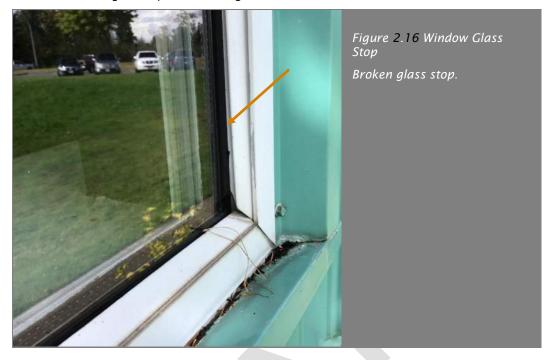
→ It does appear that some of the insulated glazing units, specifically in the exercise rooms, have been replaced, however we noted that some of the glass stops were broken during the replacement (Figure 2.16).

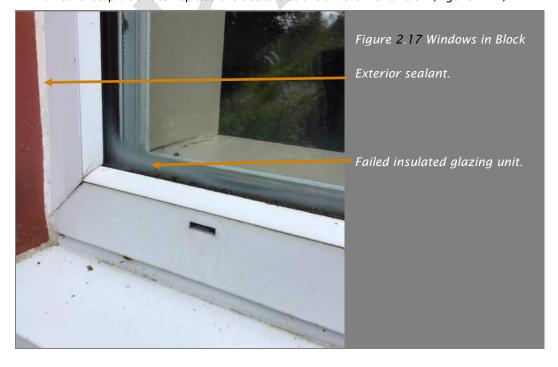
→ Windows within the block wall appear to be in better shape compared to the windows in the metal clad areas. This is likely due to their more protected locations at the lower level. We did note that there were several failed insulated glazing units in these windows. The perimeter sealant has not yet reached the end of its service life however it would be prudent to replace the sealant at the time of renewals. (Figure 2.17).

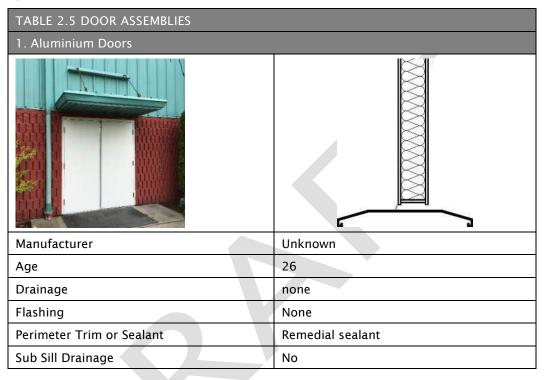
The doors primarily consist of steel swing doors with single and double leaf swing doors. Many of the doors have adequate overhang protection, in the form of canopies or overhang protection. Due to the location of the complex many of the doors are likely exposed to some wind driven rain.

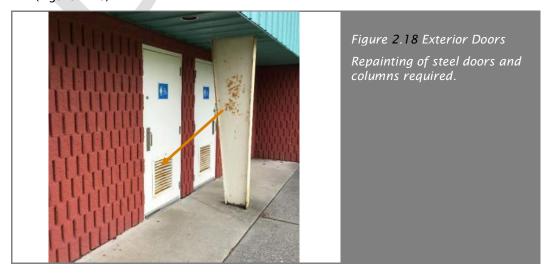
→ Corrosion identified on several of the painted steel doors and the steel columns (Figure 2.18).

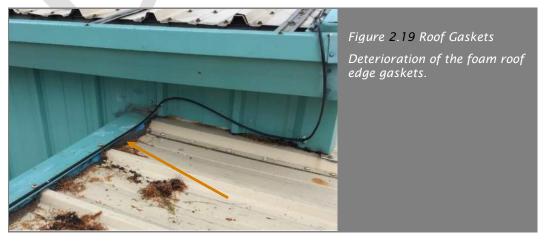
→ The foam gaskets at the roof edges are a key component to resist water ingress behind the panel. We found the gaskets are deteriorated and therefore not effective (Figure 2.19).

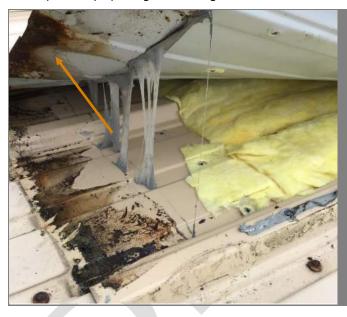
→ Corrosion was found at the edge of the metal roofing at a lap joint in the 2 exploratory openings made (Figure 2.20).

Figure 2.21 Roof Corrosion Corrosion of the metal roof panel.

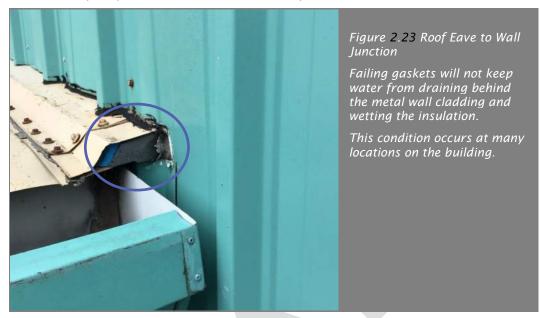
→ Where the roofing ends along the plane of an exterior wall there is no means to direct water away from the wall panels (Figure 2.20). Given the amount of membrane remedial work observed it reinforces the assumption that this detail does not effectively keep water out of the wall assembly.

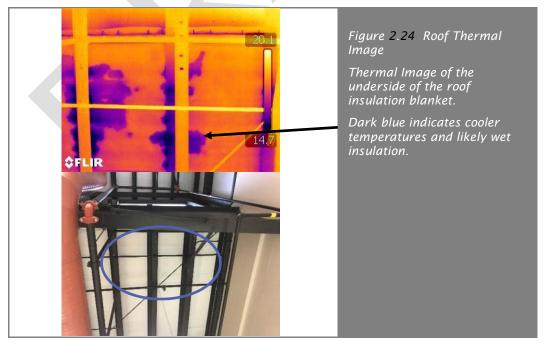
→ A thermal scan was performed at random locations from the interior. A location was selected just outside the women's change room below the clerestory window where leakage has been reported. The thermal scan shows cooler temperatures in the insulation blankets which could be the result of water in the insulation (Figure 2.24).

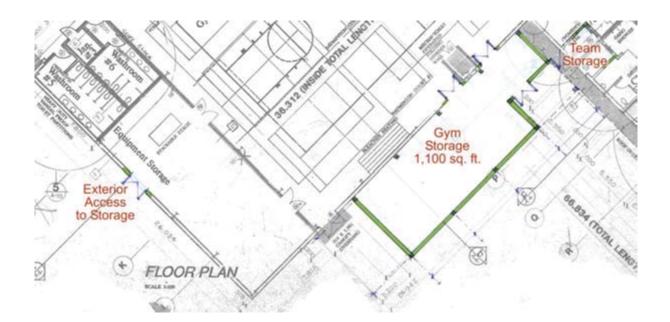
To address the shortage and accessibility of the gym storage, a new storage room is proposed on the southwest side of the gyms. This room would have access to both sides of the gym so that either gym could access without disturbing the other side. Items in this room would be those that might be needed by either gym. Access is also provided directly to the exterior for loading directly into either gym during special events.

The existing storage room would continue as a general storage for administration and the overall facility, items only needed by the north gym, as well as storage for items which are associated with the outdoor activities and the summer camps. Exterior doors are added to provide direct access from the exterior.
